# ALTITUDE WIND TUNNEL DEMOLITION

# AWT

## A brief history

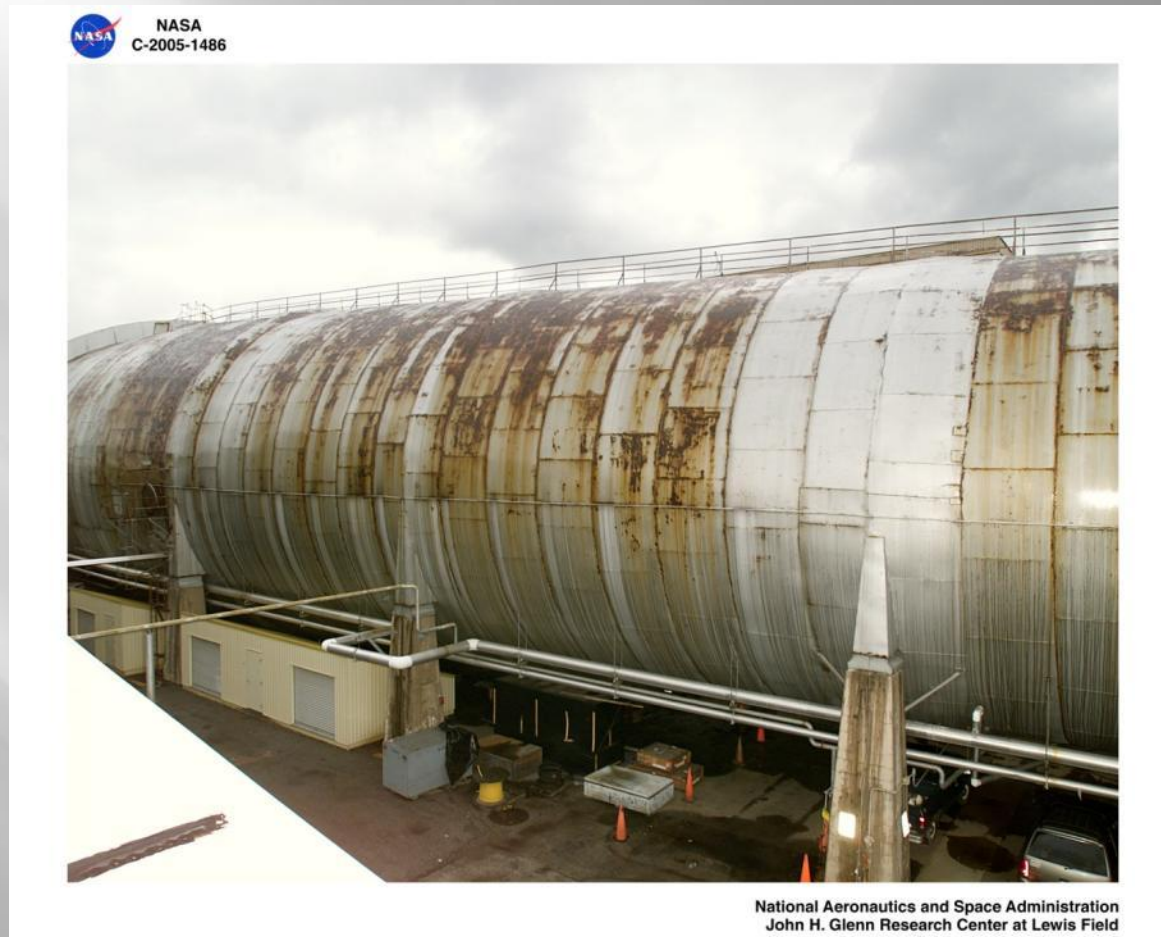
## Piping rerouted prior to demolition

Steam, condensate, air, and natural gas piping were rerouted prior to demolition activities

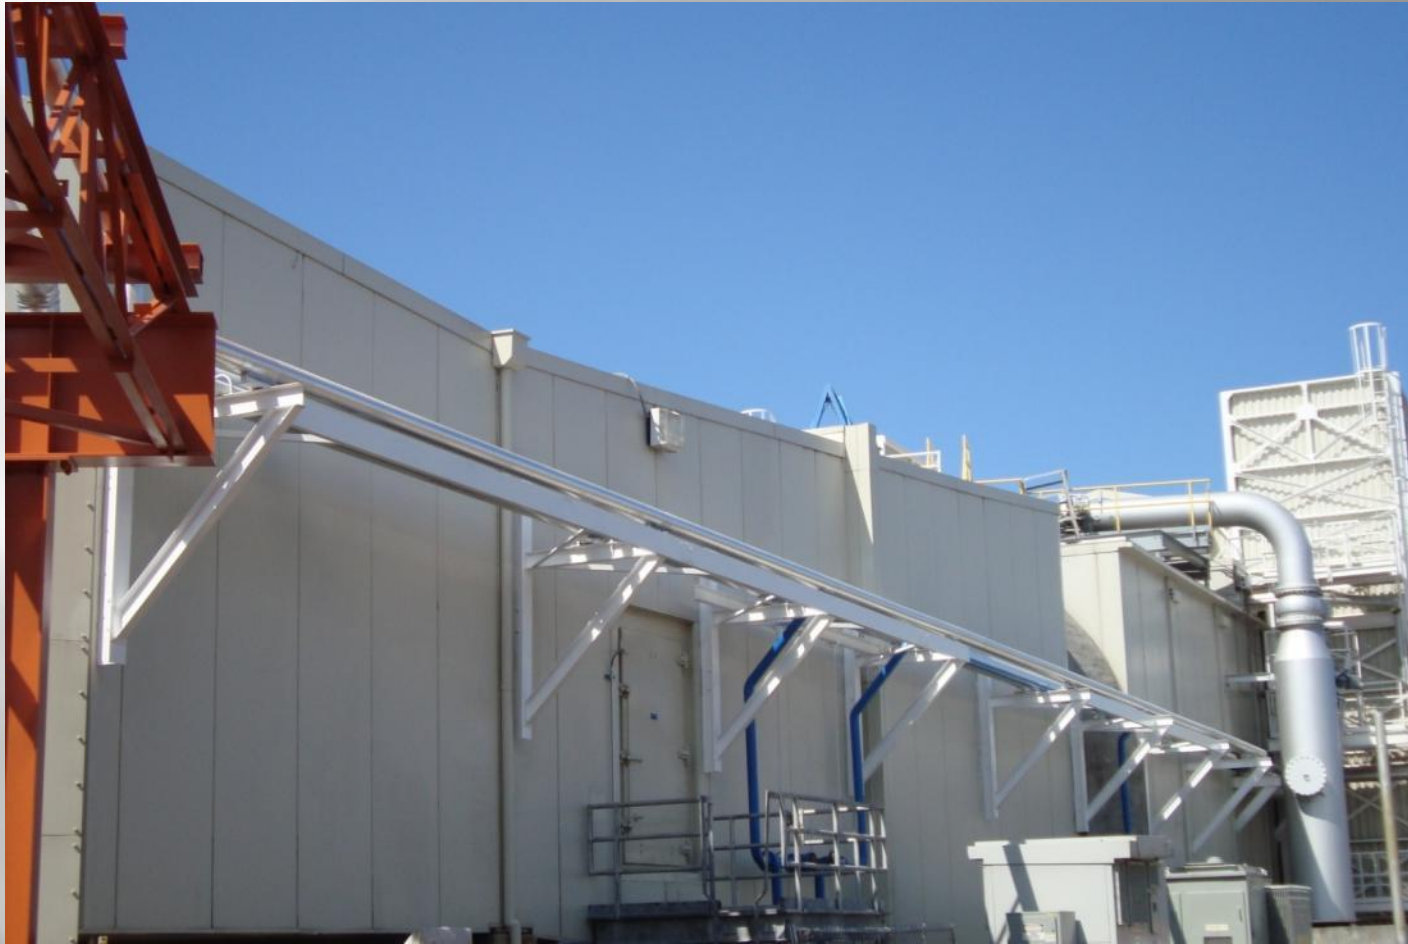
A pipe bridge and pipe supports were installed along the IRT Building for the rerouted pipe; which was then painted for identification

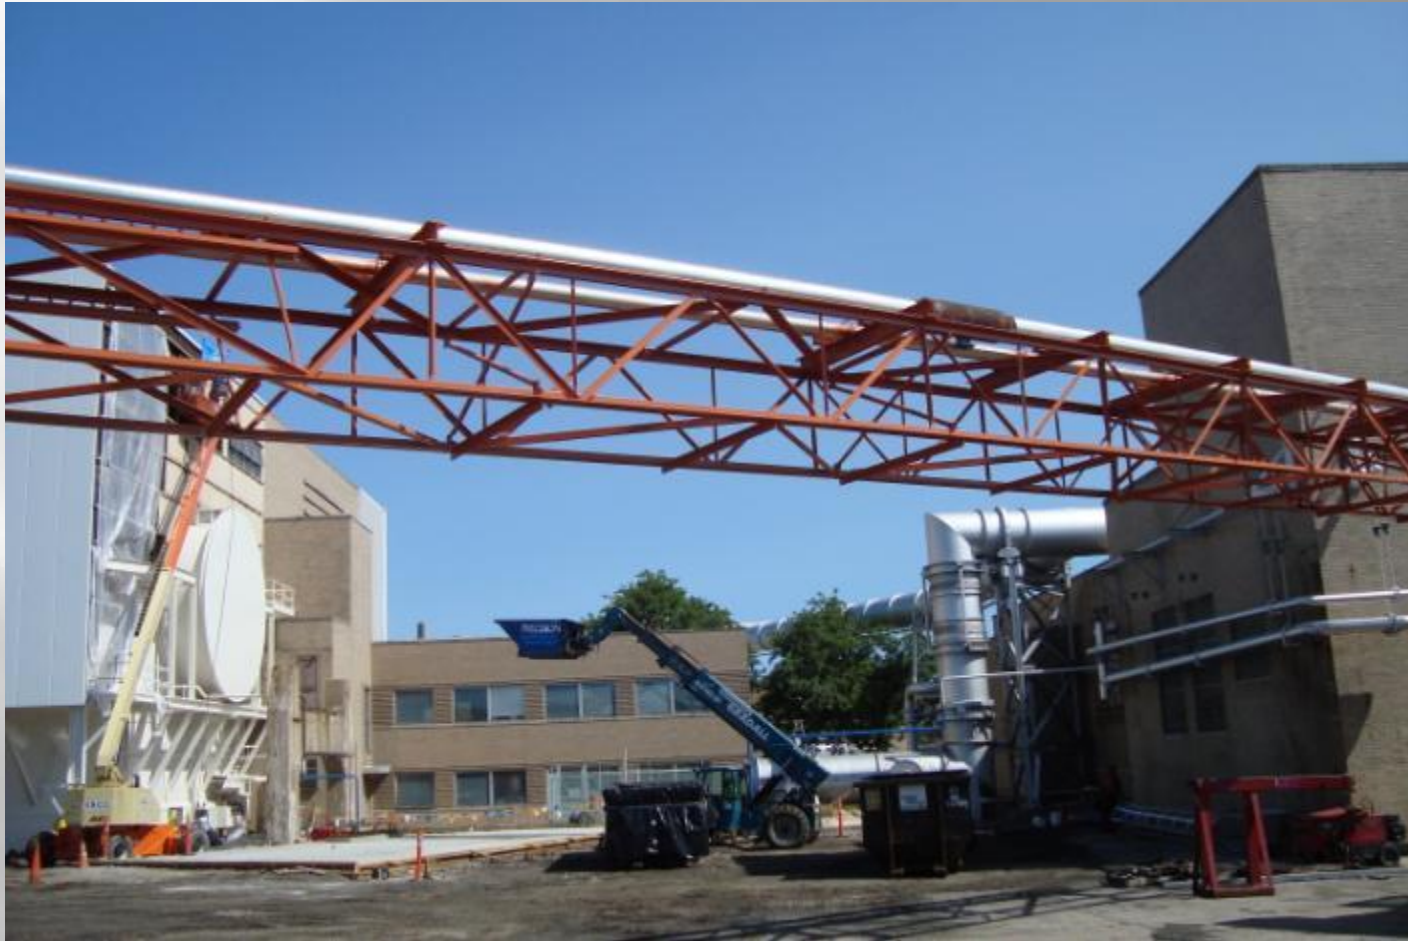
Pipe bridge installed and painted

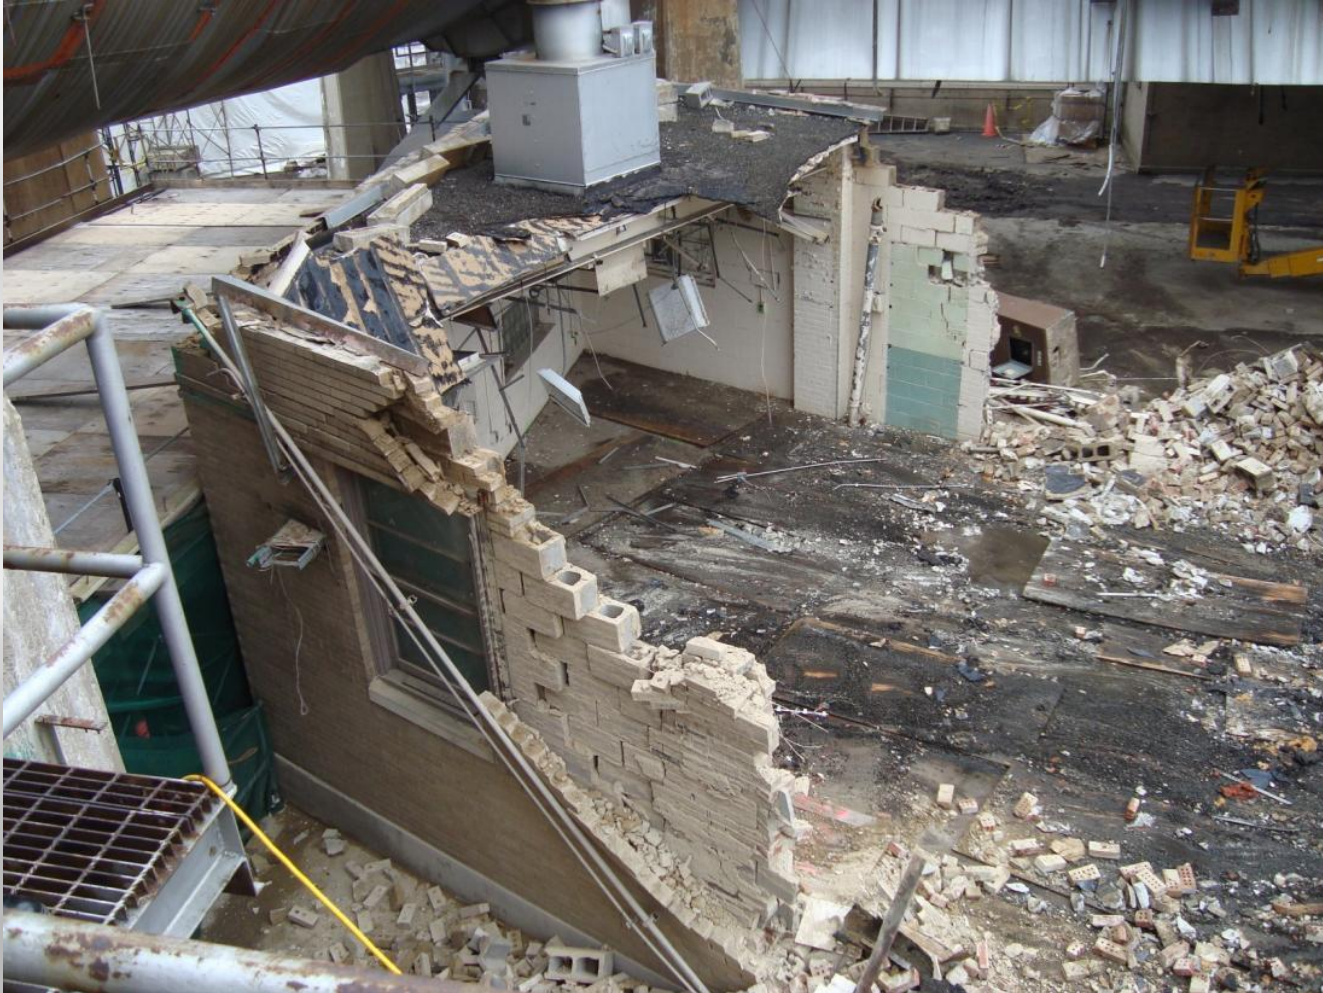
## Removal of Exterior Walls

Walls are demoed and material is removed from site

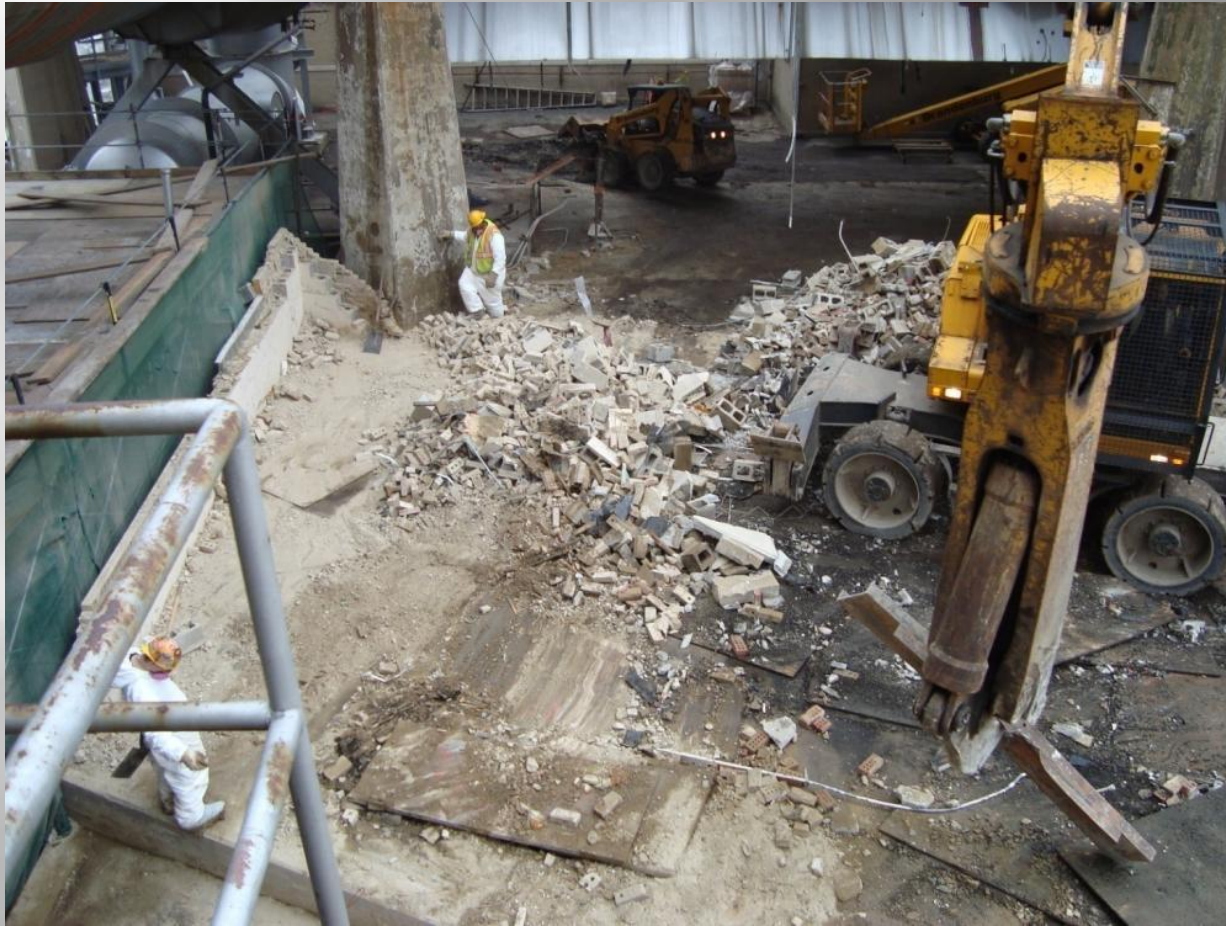
## Removal of Debris

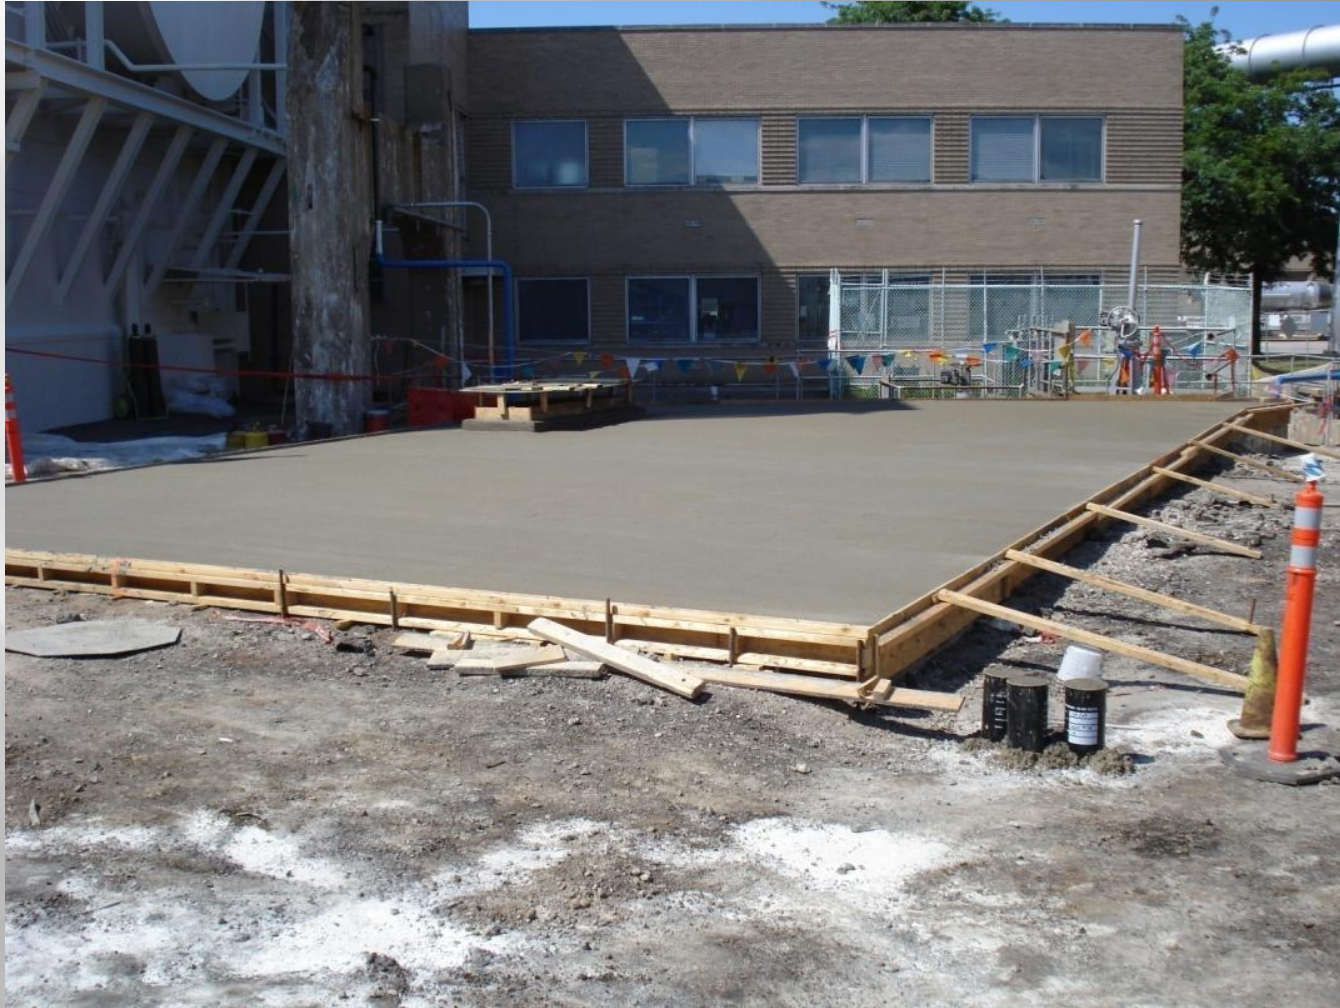
A concrete slab and hatch are installed over the remaining basement

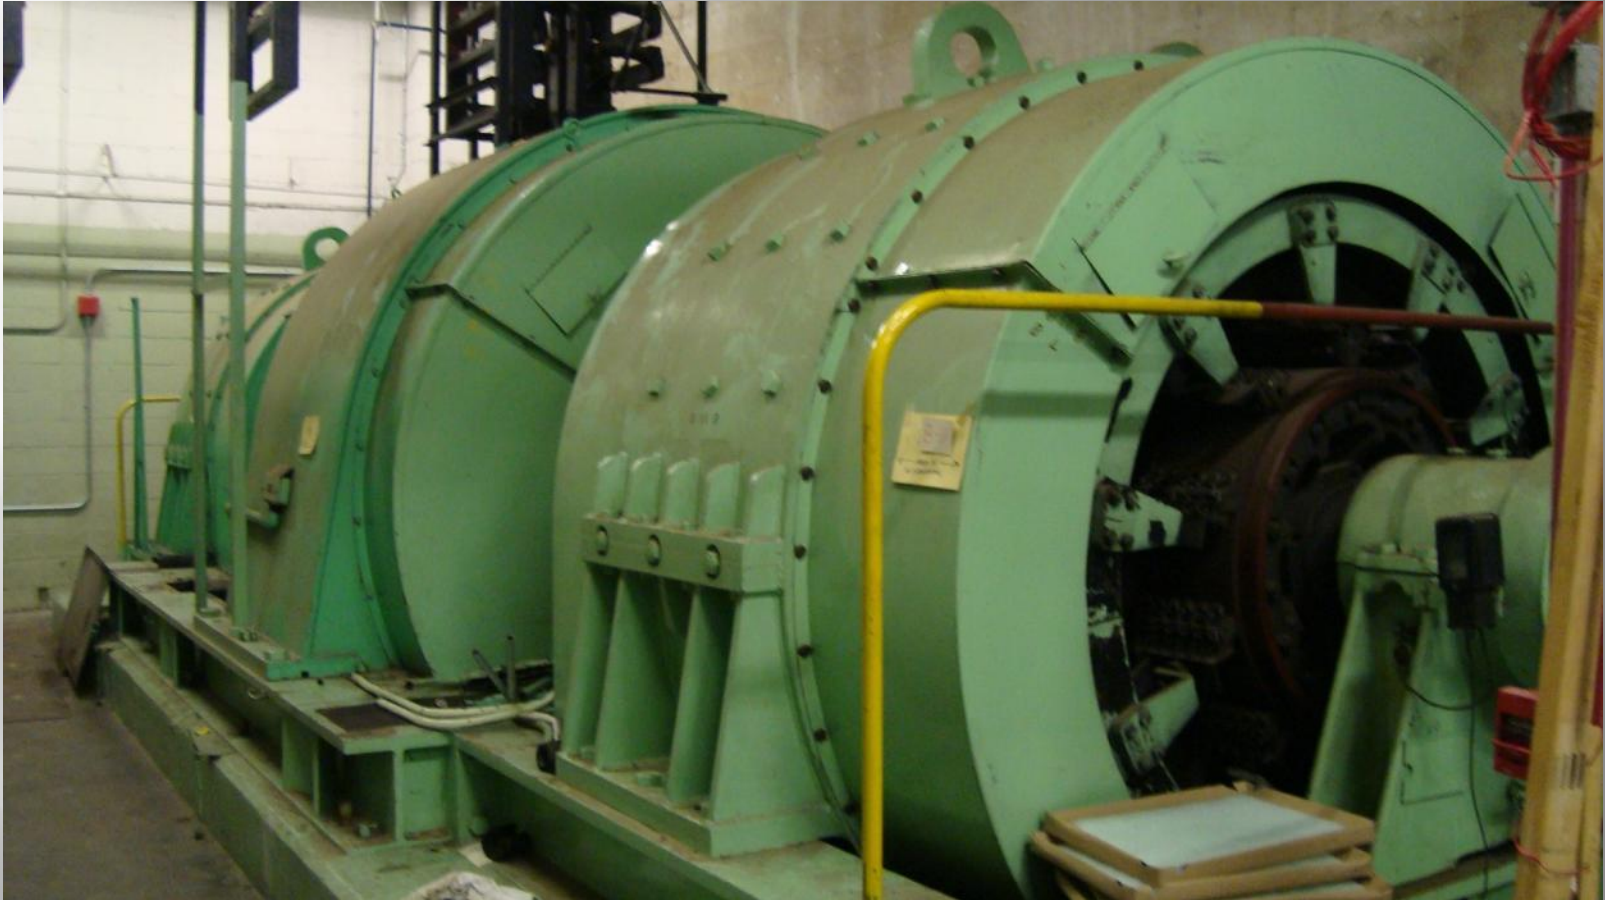
## Removal of Generator

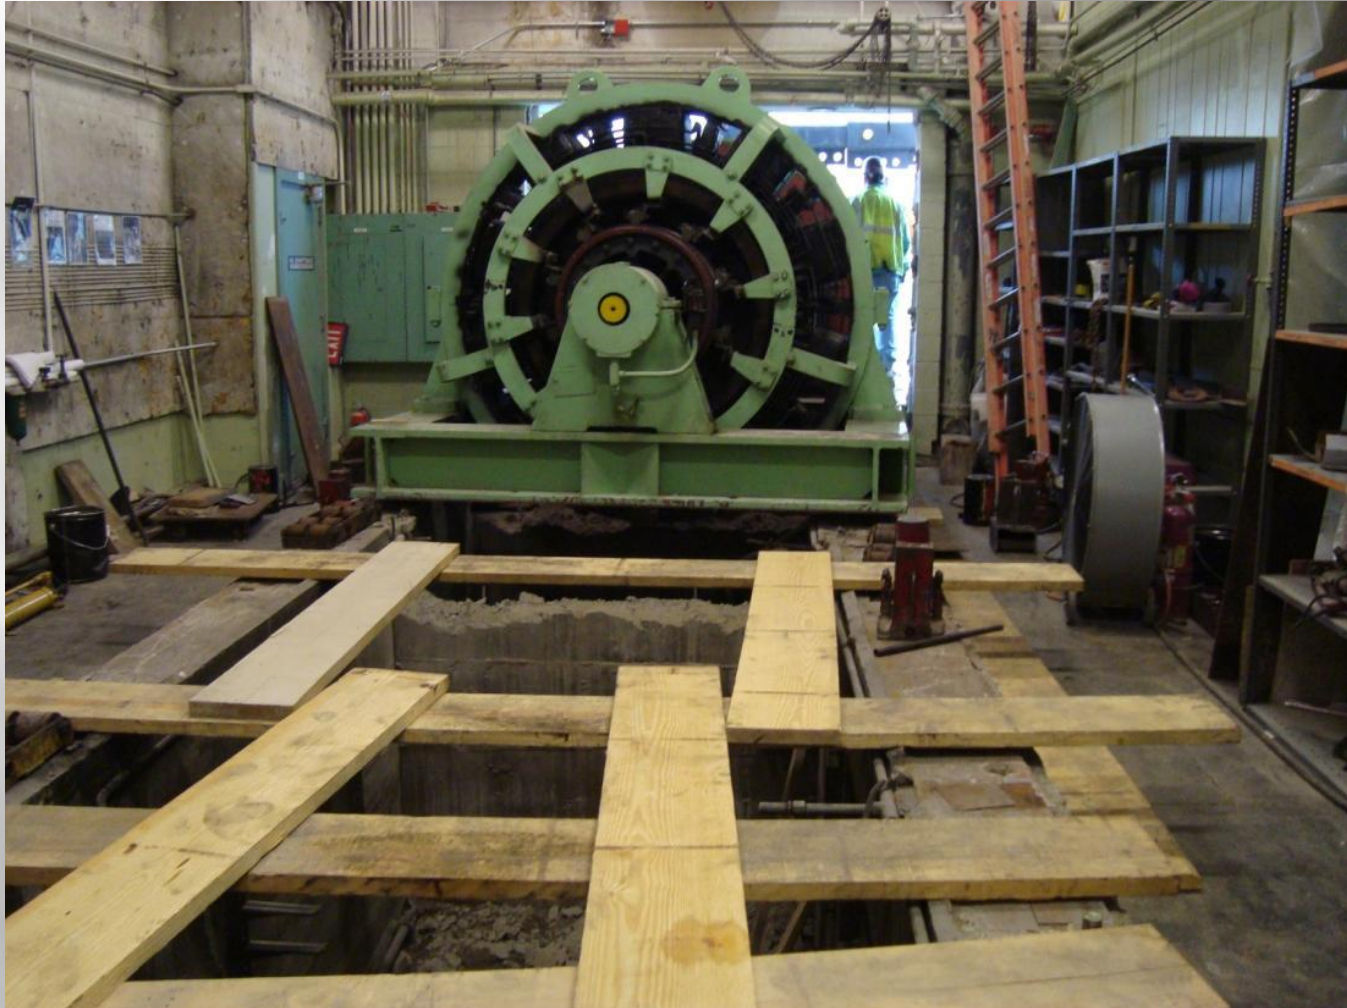
A portion of the wall was removed to allow access to the generators

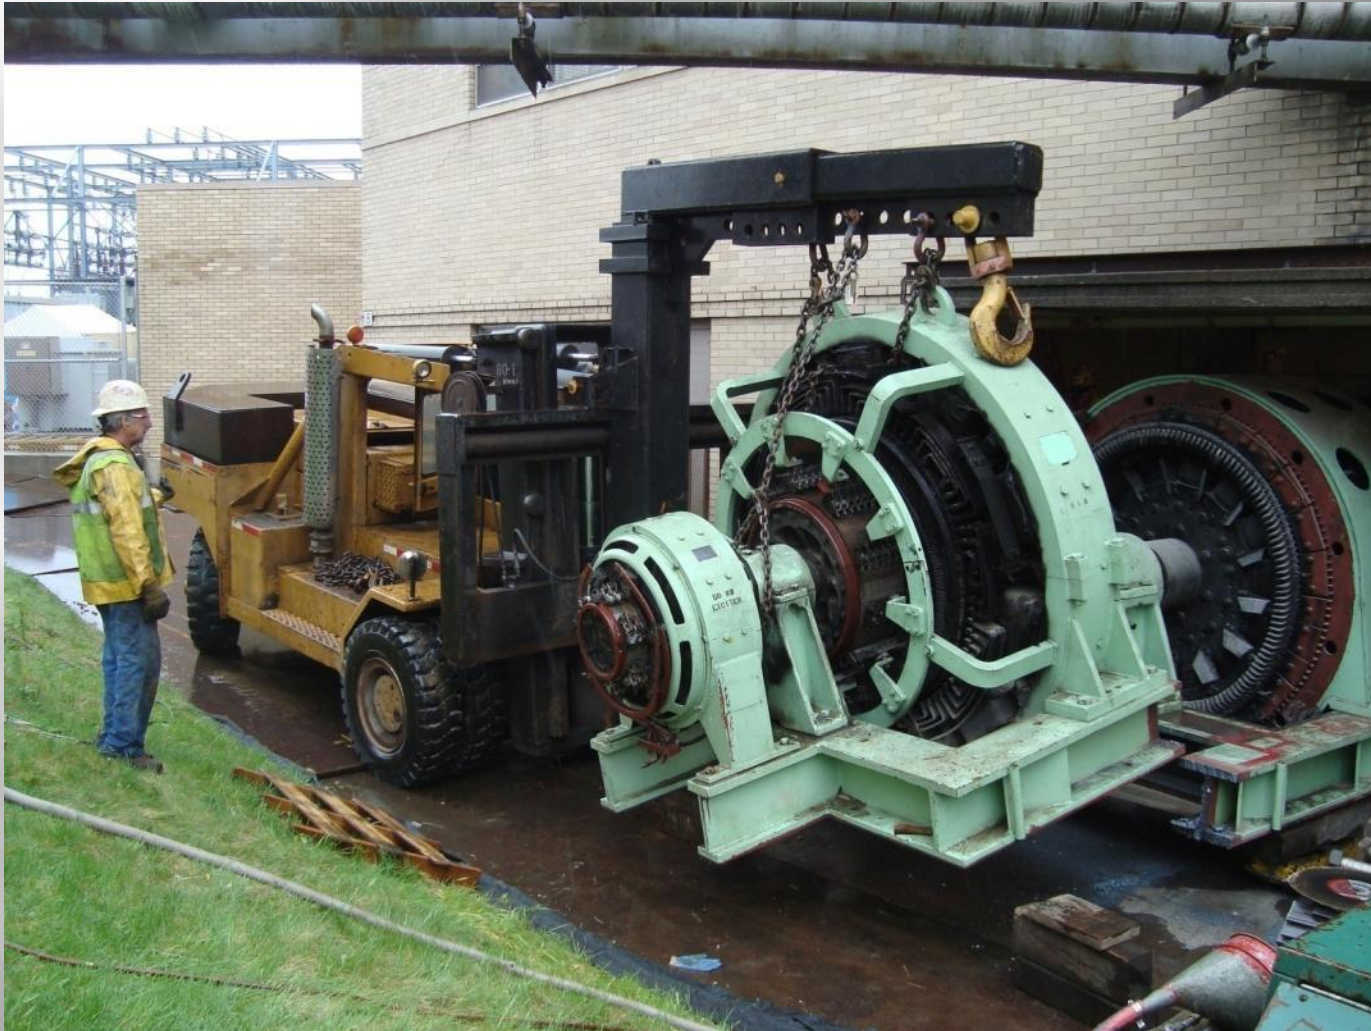
## Removal of Generator – In Progress

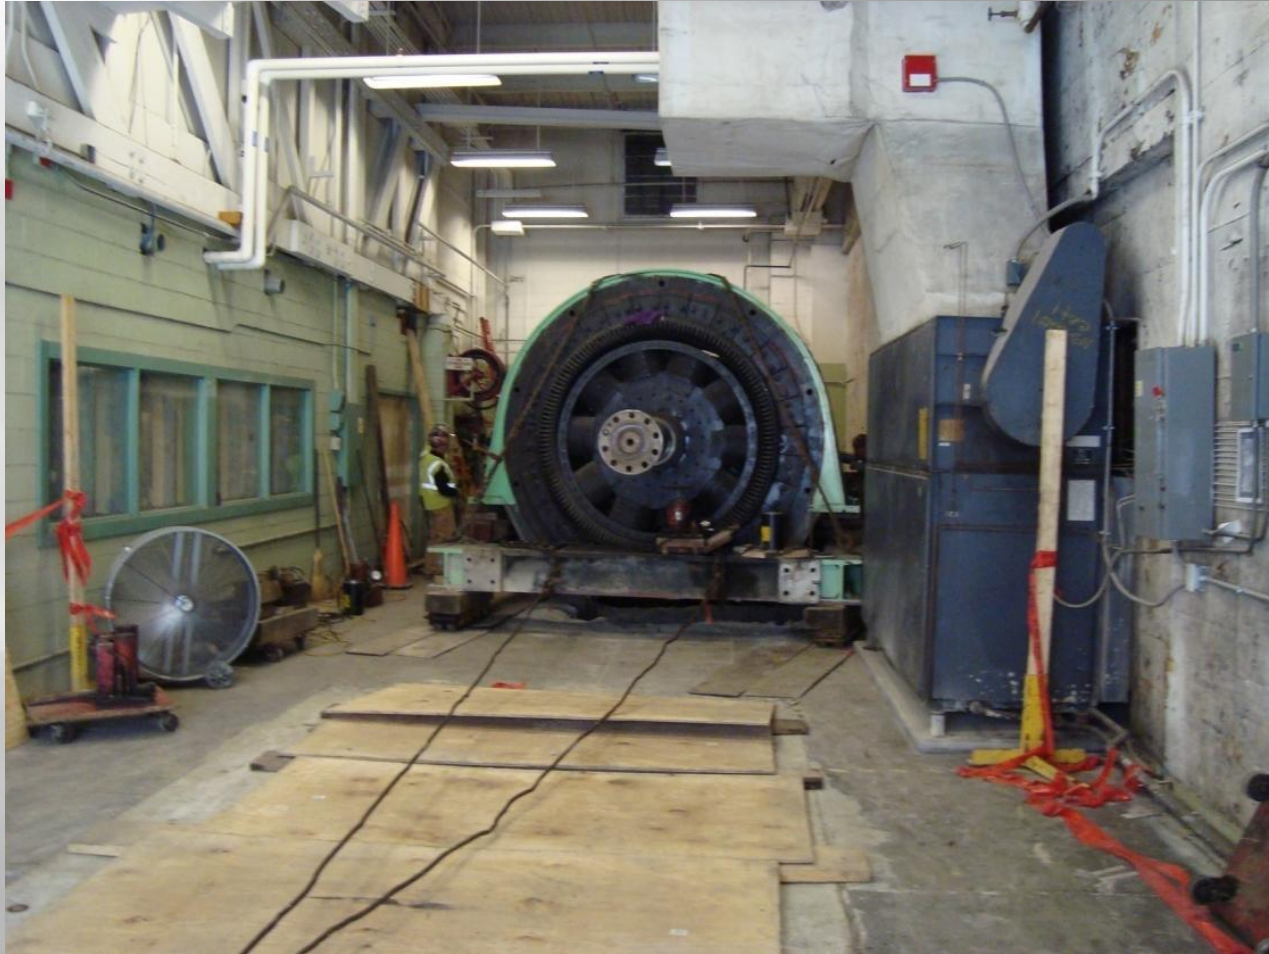
The generators are removed from the building and recycled

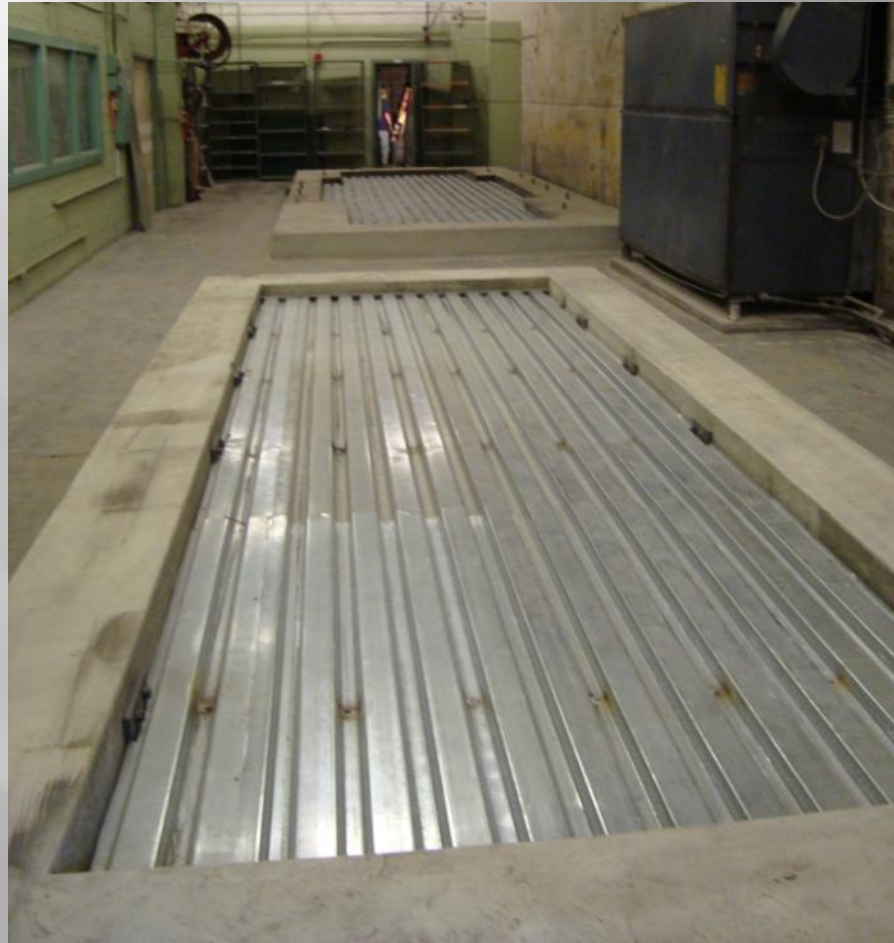
Steel decking installed prior to concrete placement

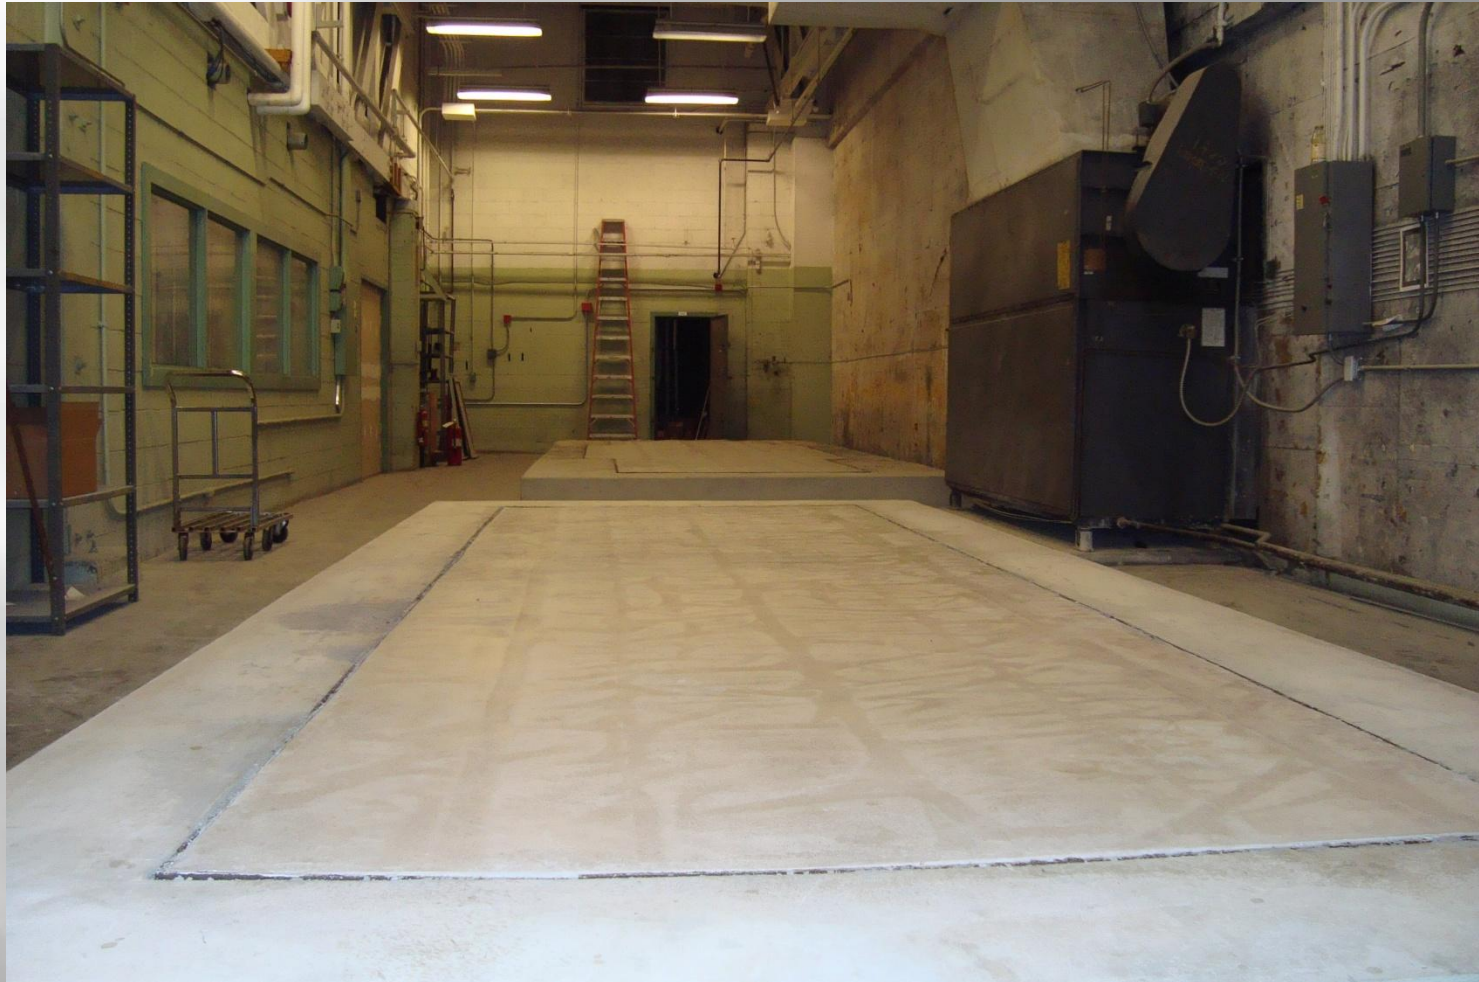
Concrete slab in place of generator foundations

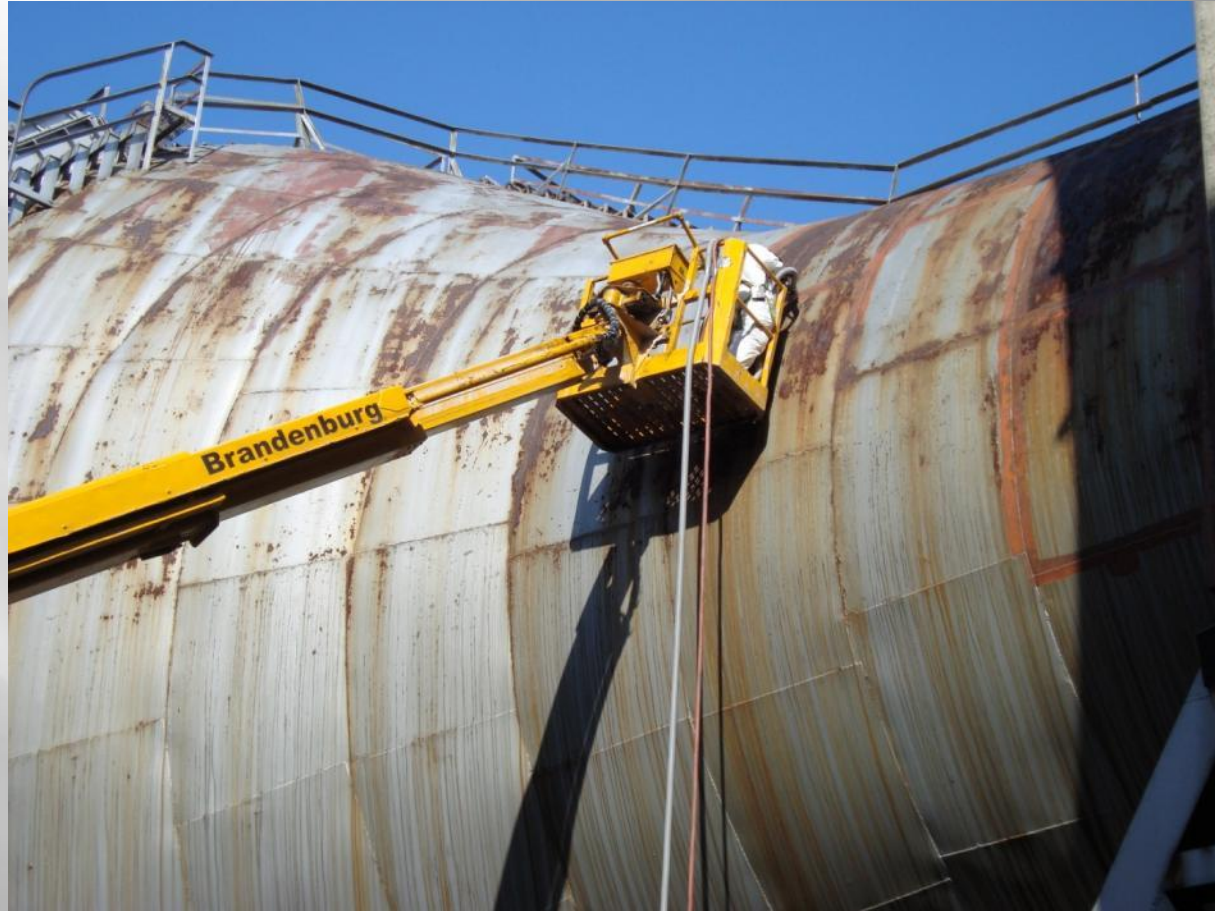
Lead paint had to be removed from all areas to be torch cut prior to removing the outer shell from the tunnel

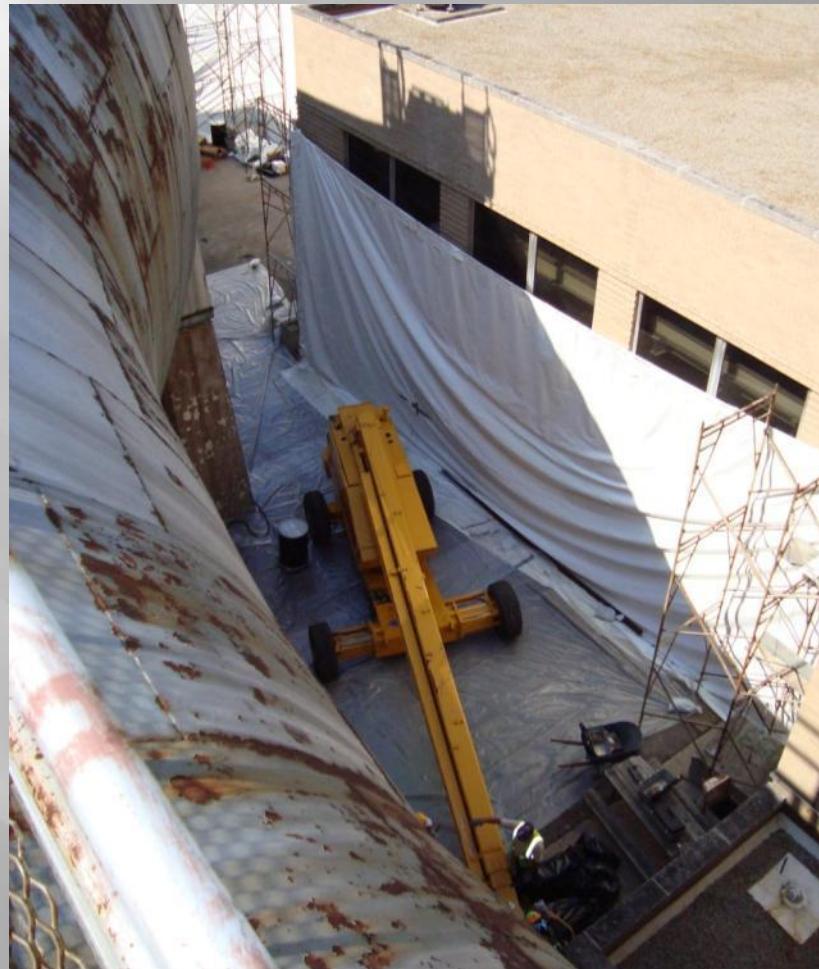
A barrier was installed before lead abatement began

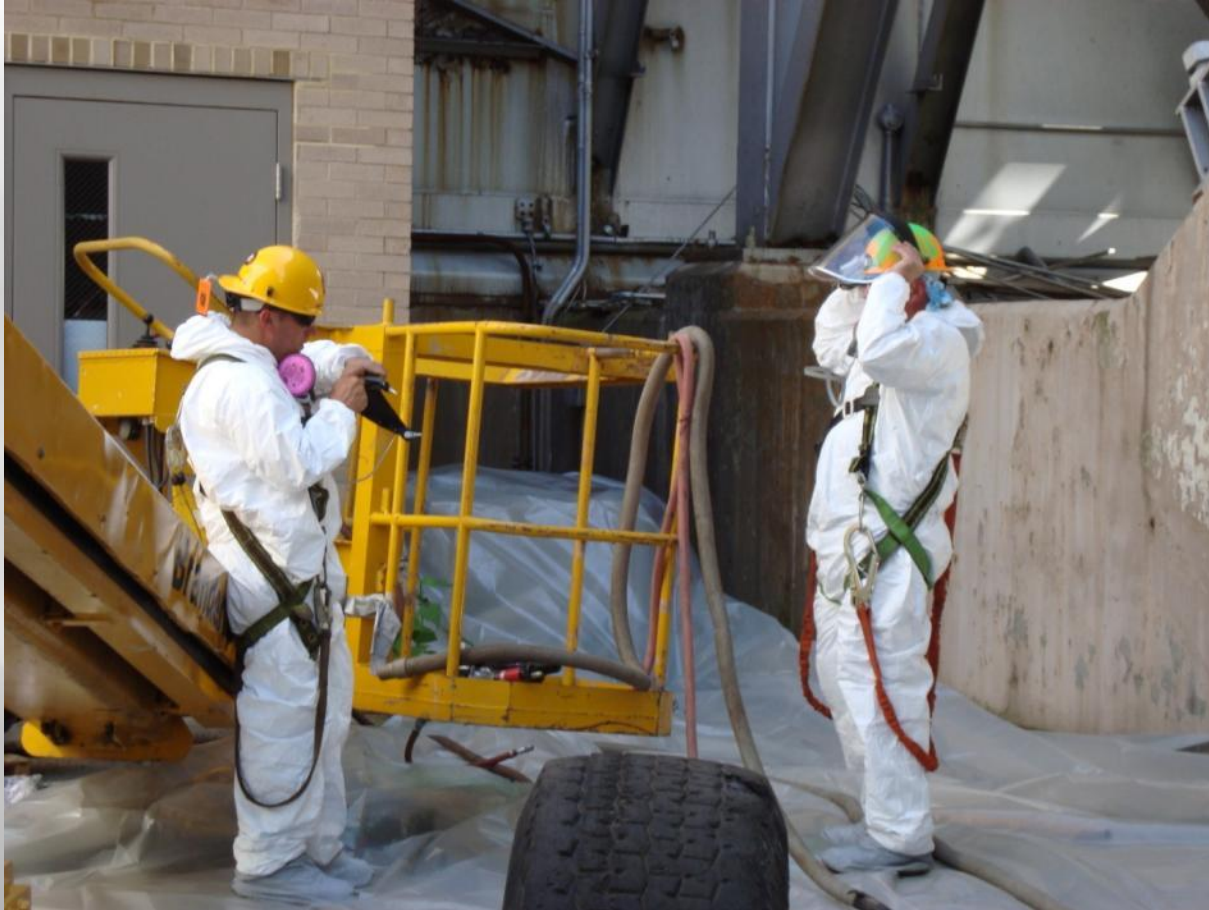
Workers wore personal protective equipment to control lead exposure – a medical exam process was also implemented

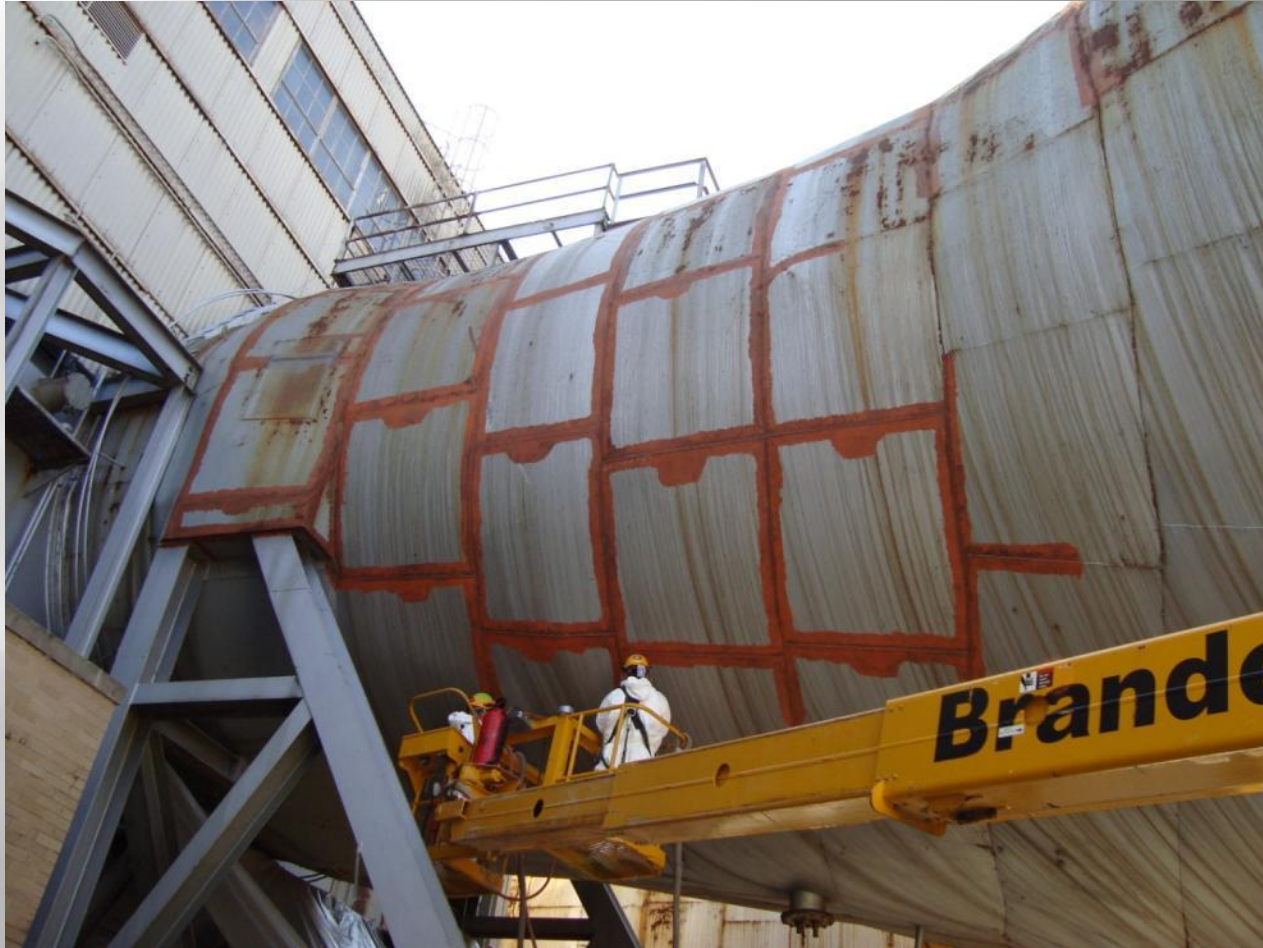
A needle gun was used to remove paint along the welds – where the panels were to be torch cut

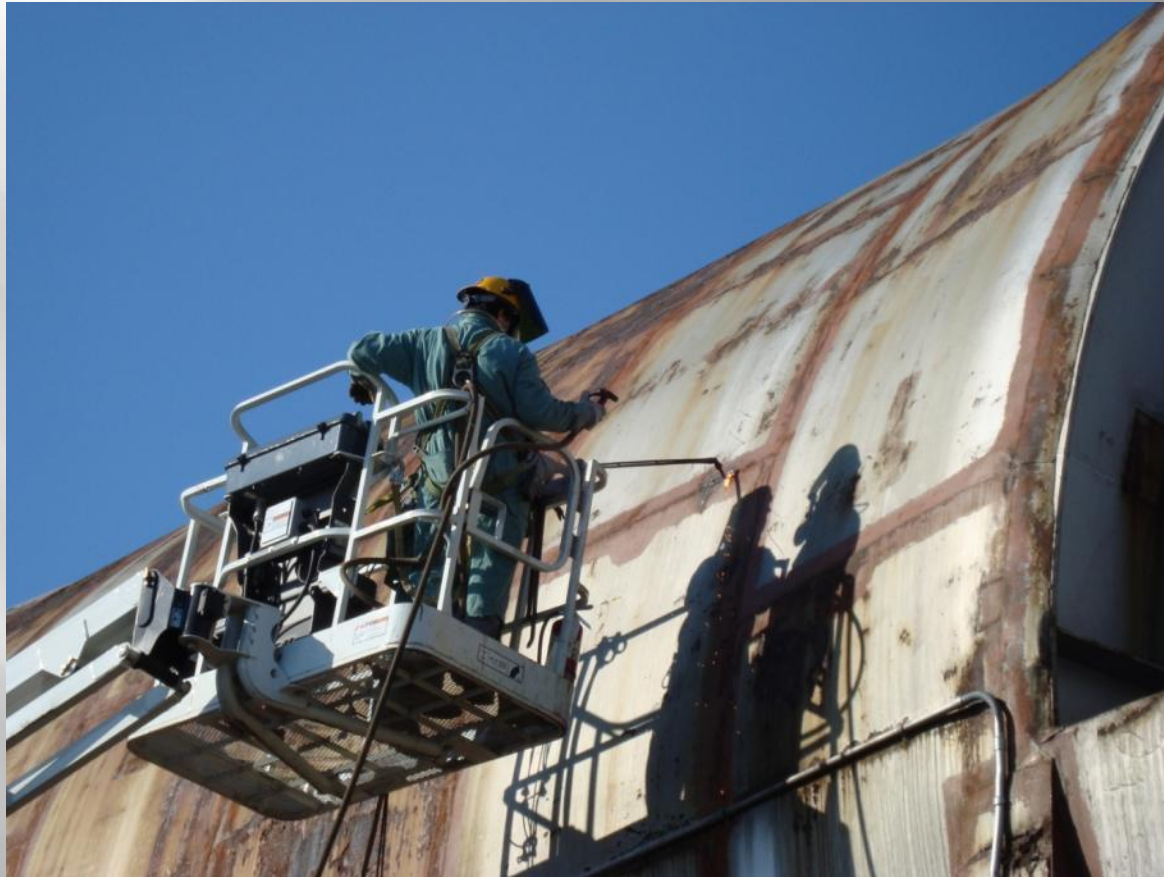
Torch cutting the outer shell – notice shadow of 2 workers; one torching, one serving as a fire watch with hose at hand

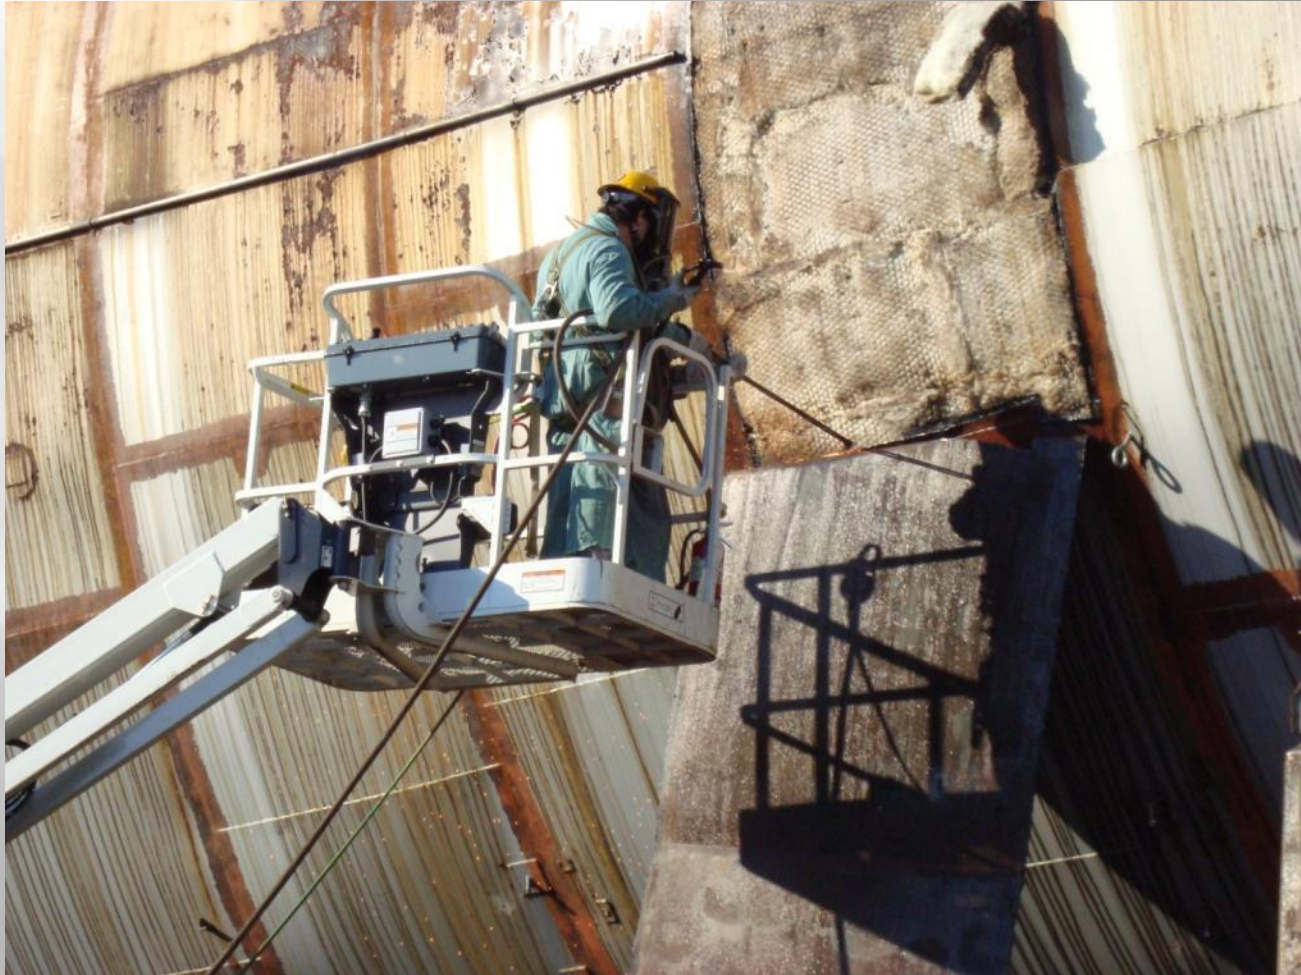
The steel plate outer shell is removed, revealing the insulation

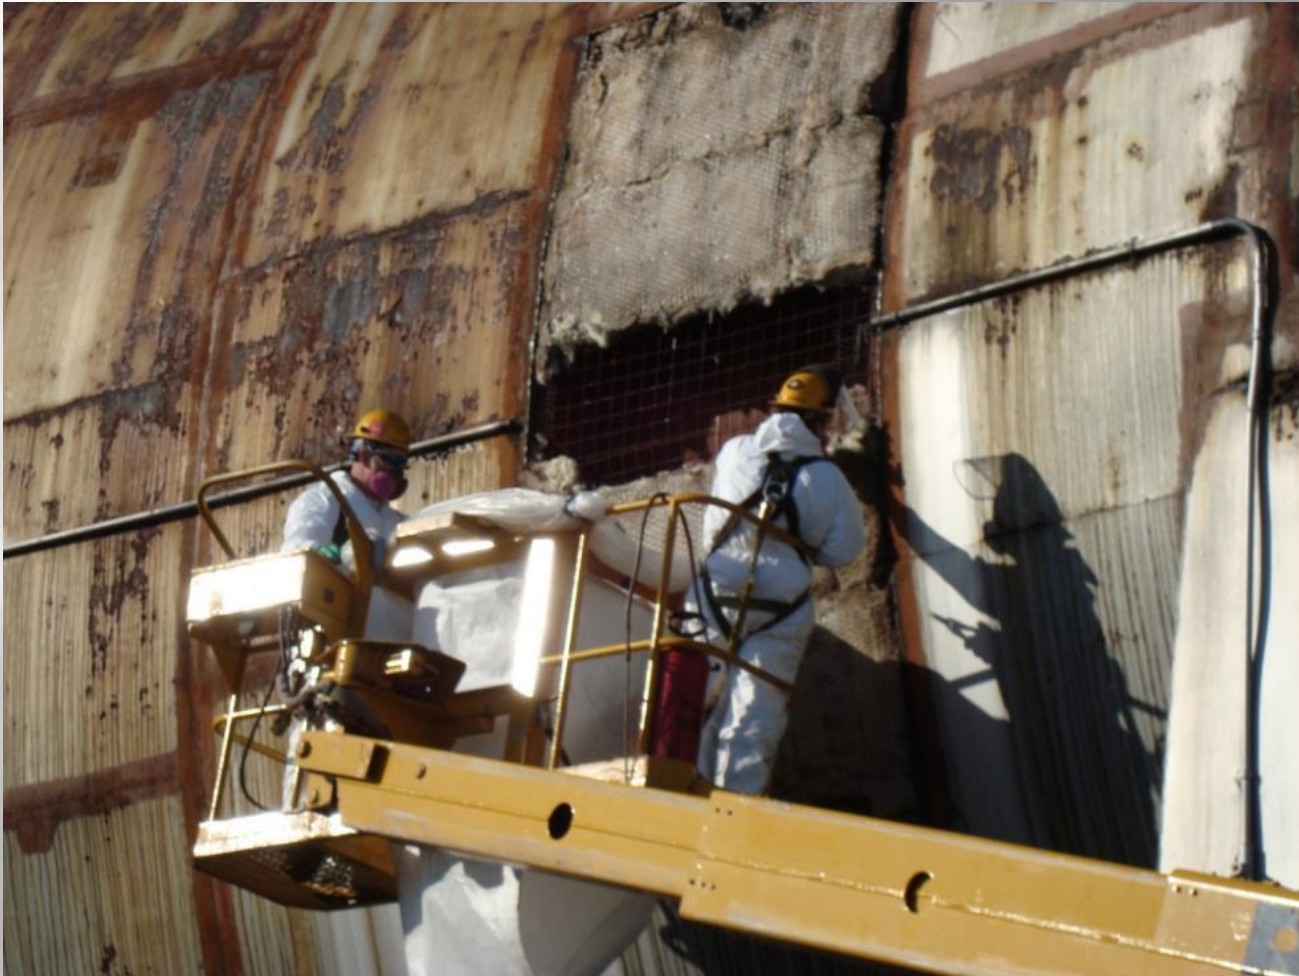
Insulation is removed, revealing wire fabric below
